Archaeological Data Recovery at the Lockville Historic Complex

Site 31CH690

**Chatham and Lee Counties, North Carolina
TIP No. R-2500
State Project No. 6.409006T**

**North Carolina Department of Transportation
Planning and Environmental Branch
Raleigh, North Carolina
May 1998**

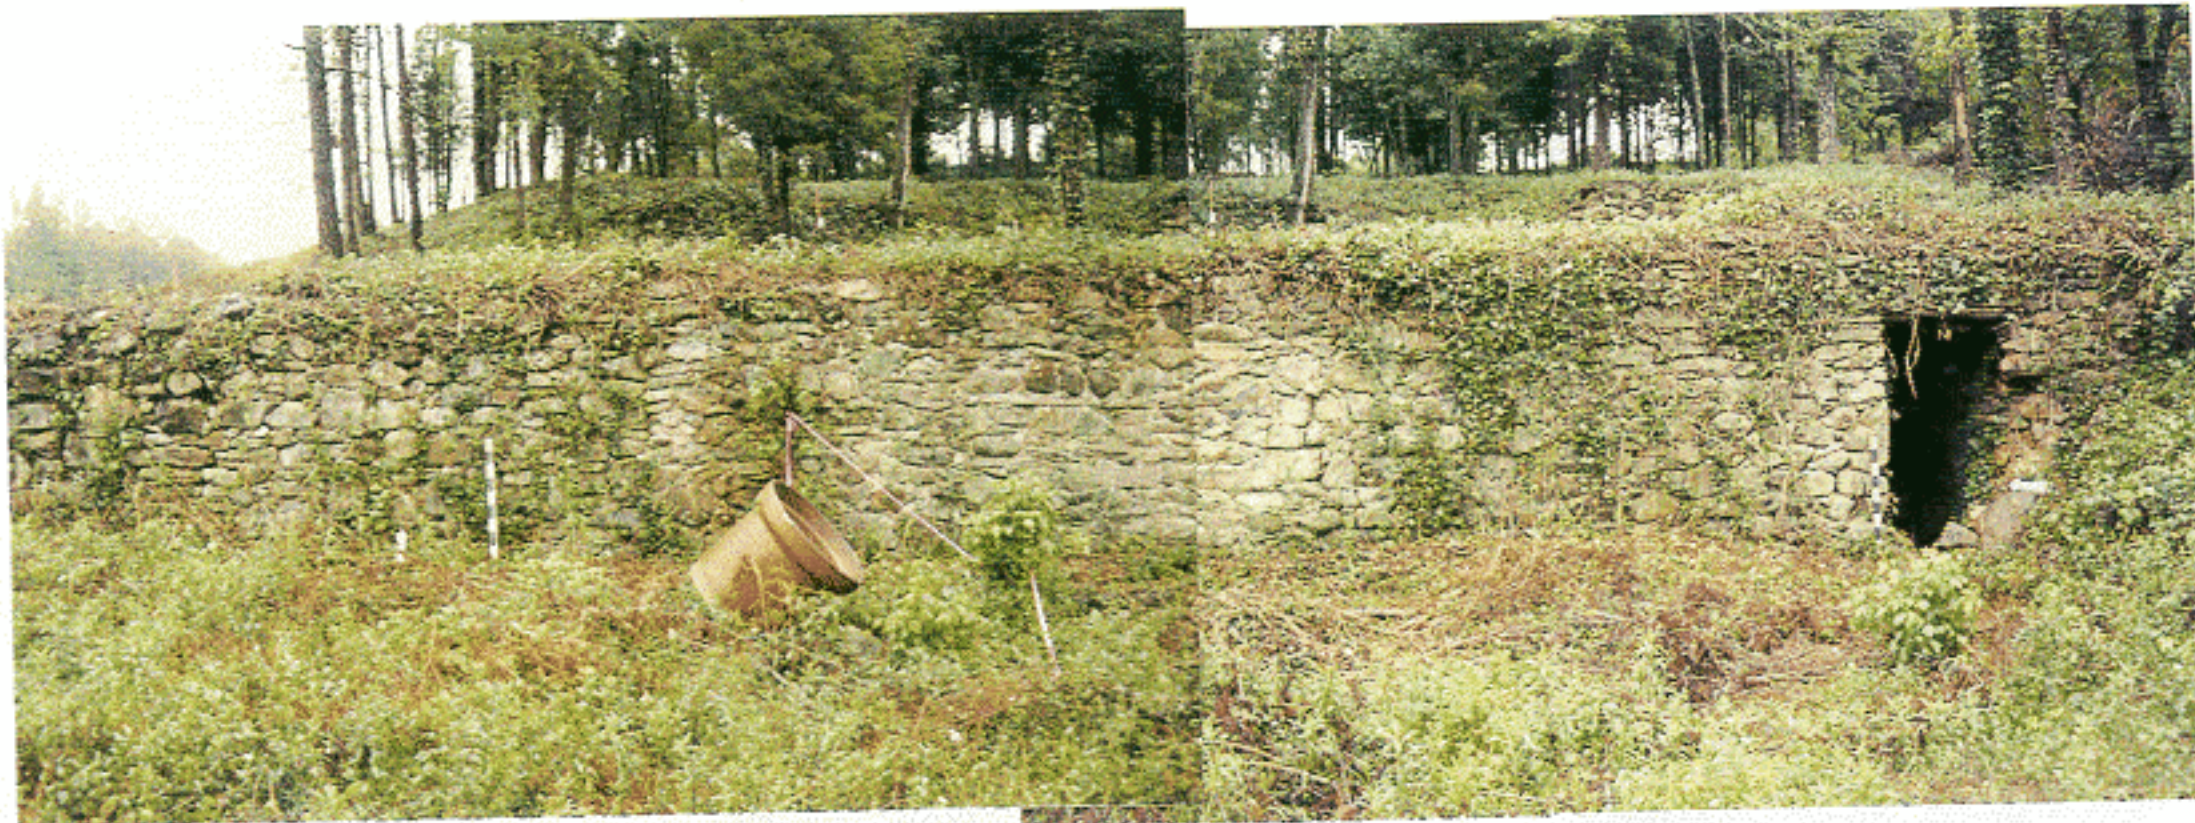
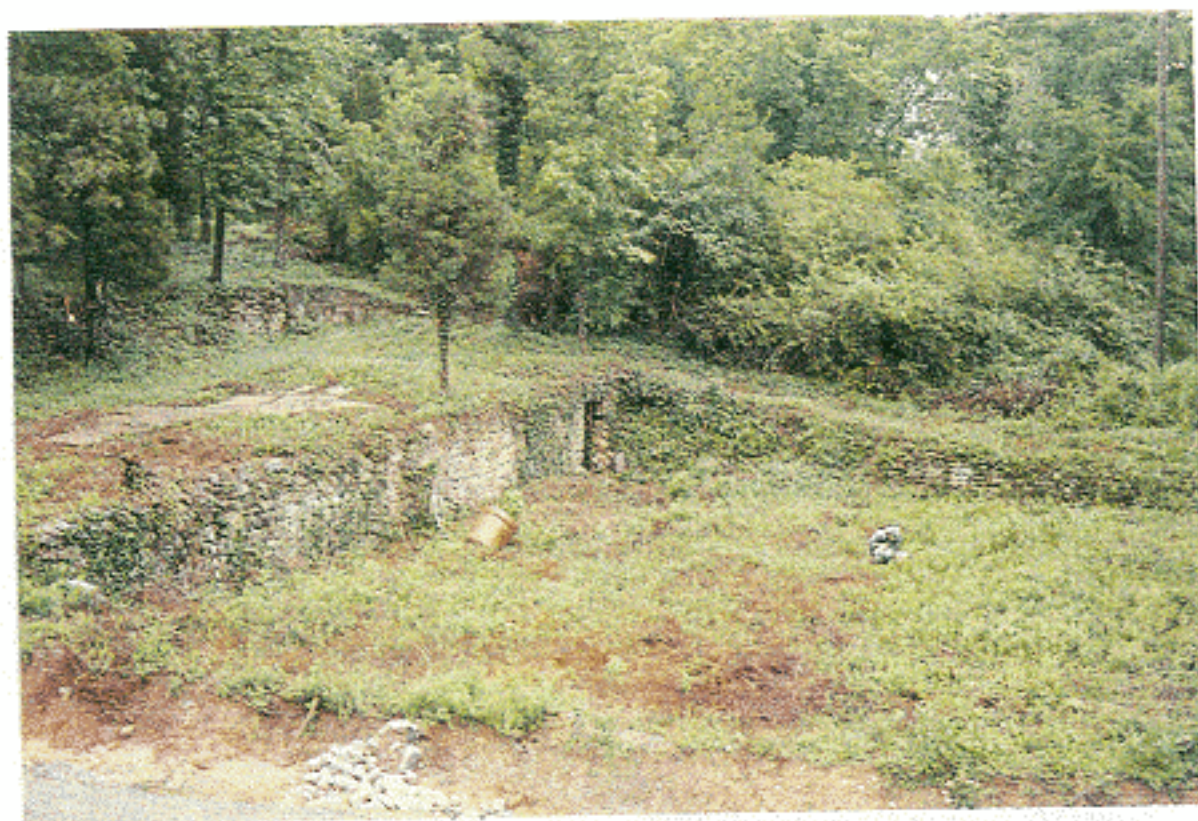
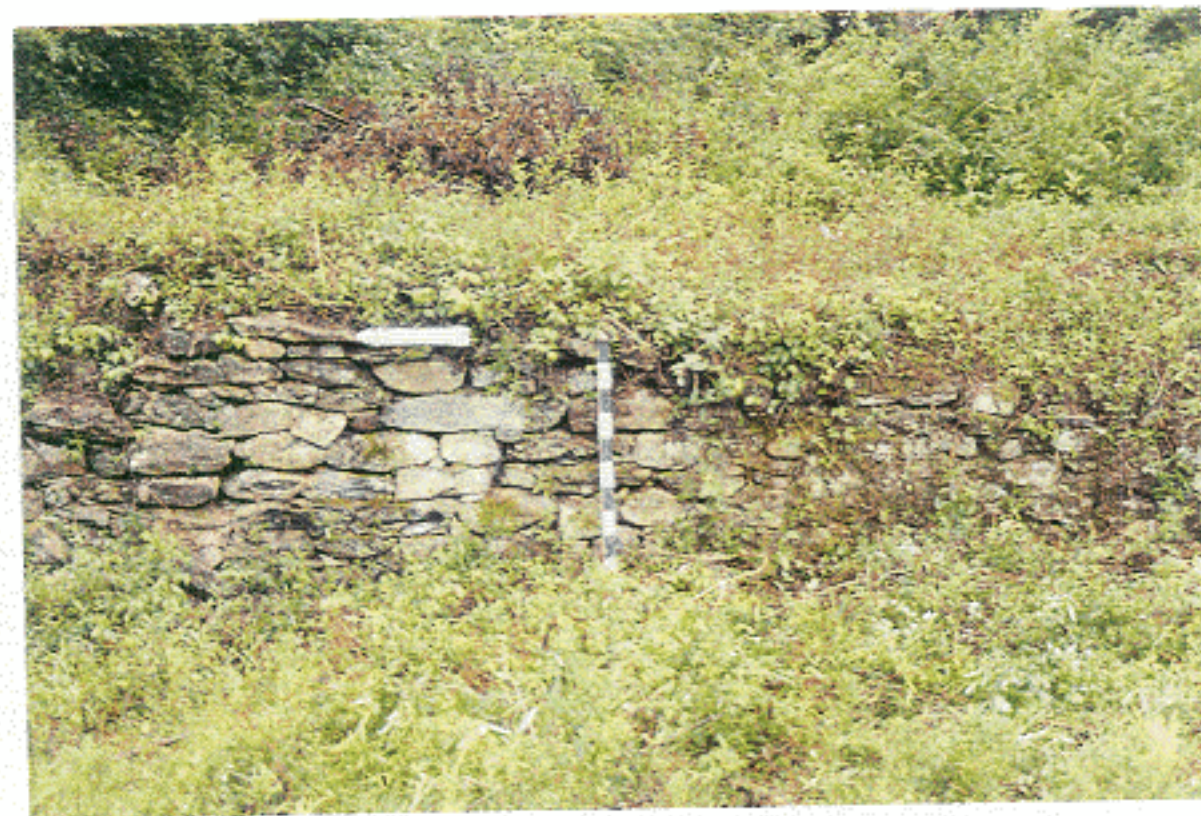
Figure 29. General View of Lower Retaining Wall (Wall 1) and Cellar Opening. (a) Tile Pipe in Foreground Marks Well; (b) Lower Terrace and First Terrace; (c) East Side of Wall 1.

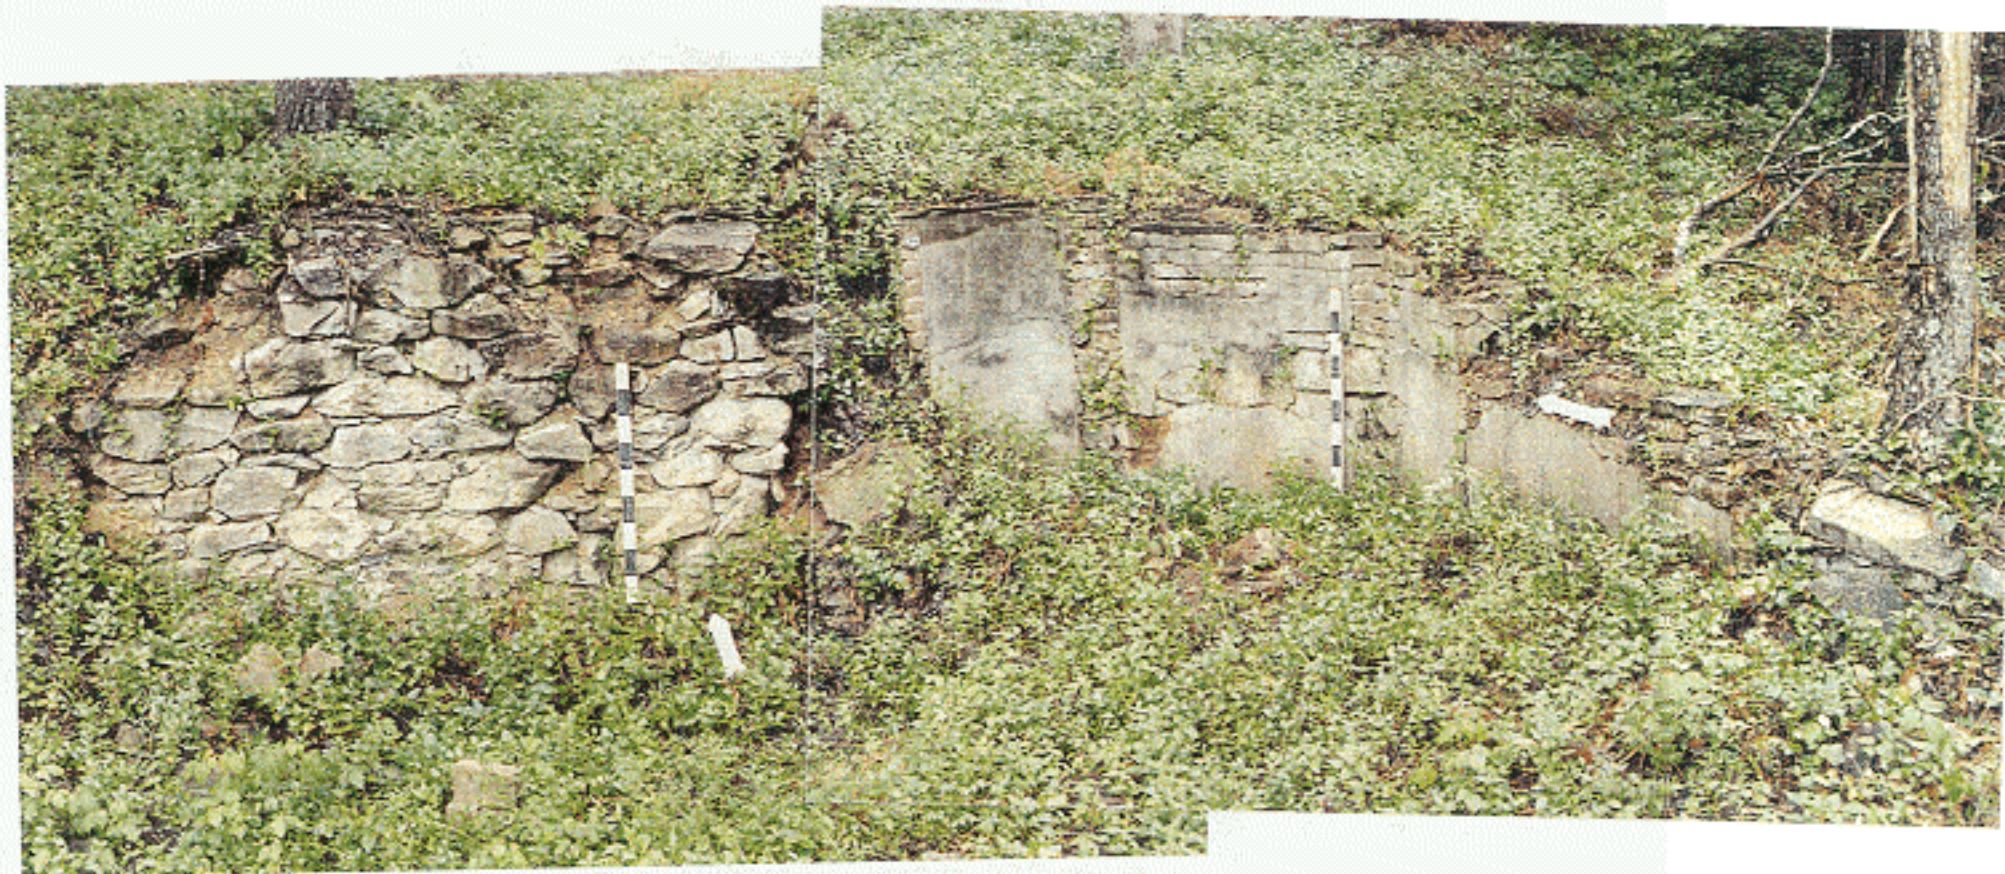
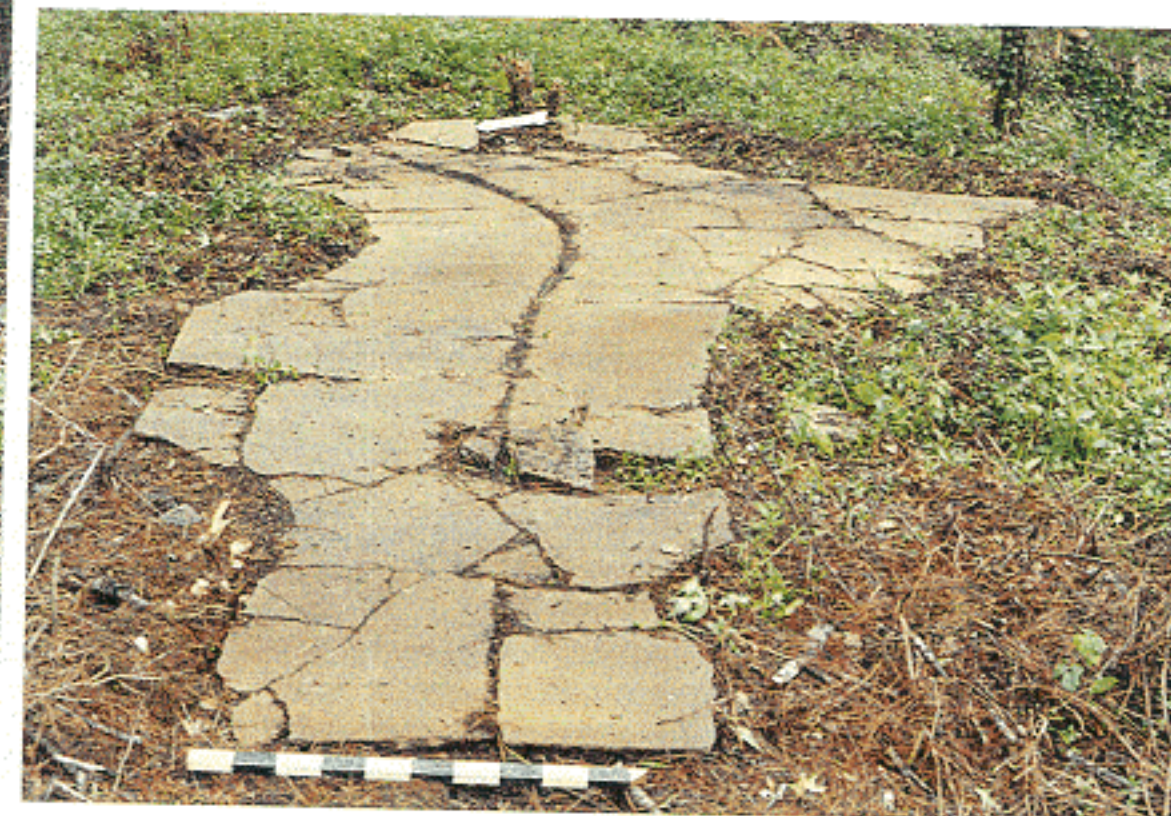
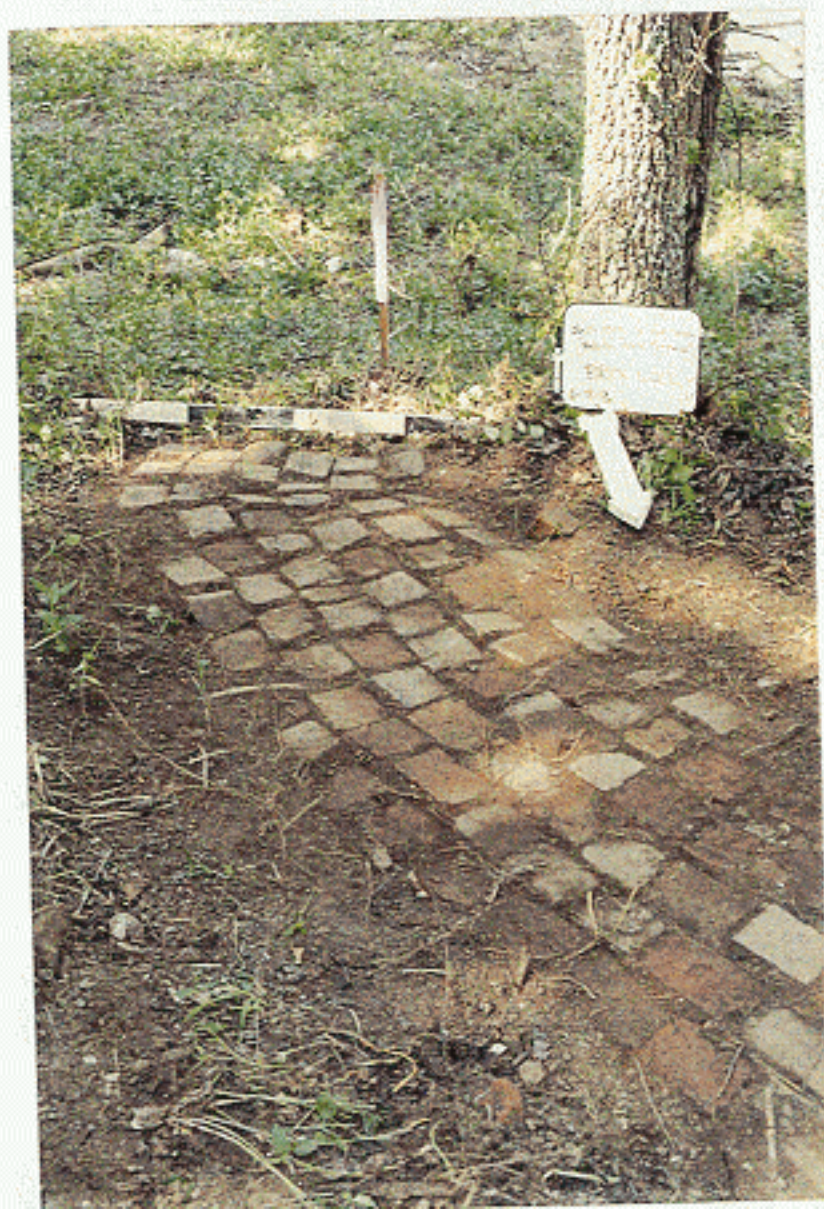
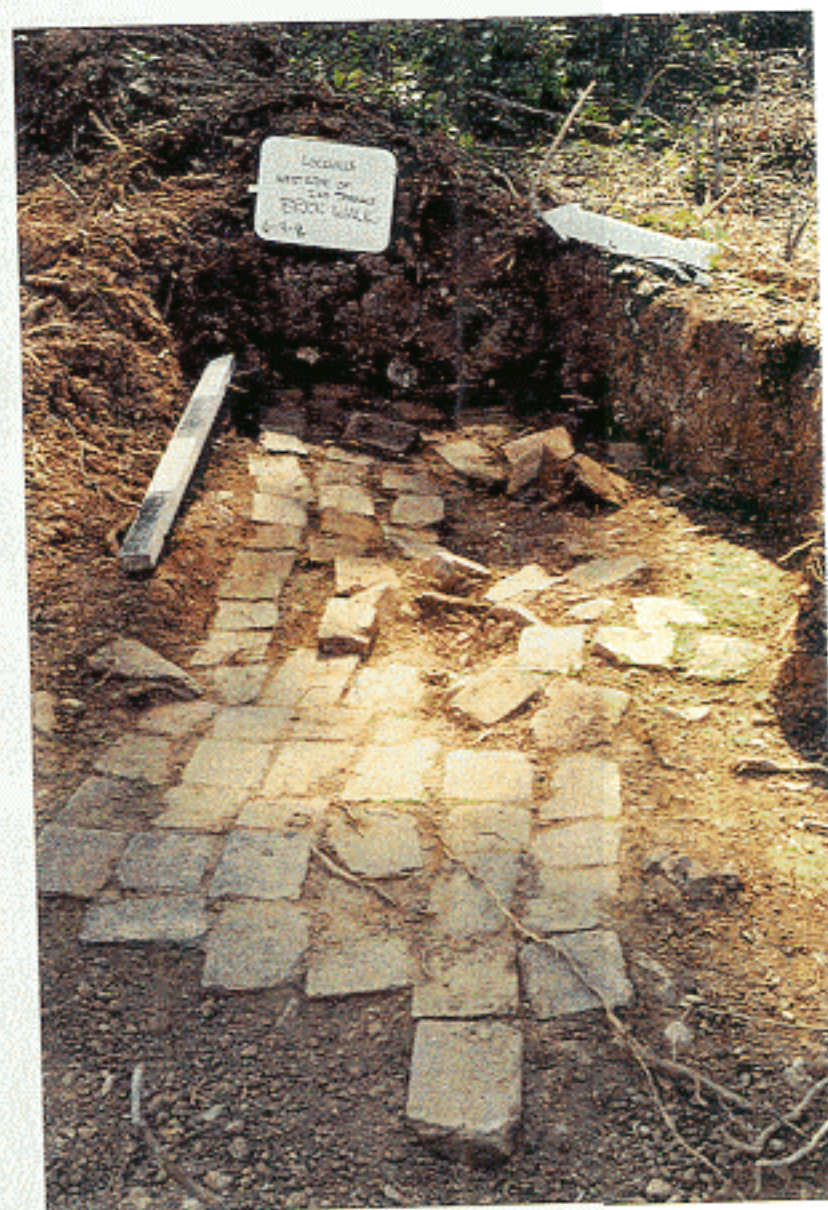
Figure 30. Photographs of (a) Upper Retaining Wall (Wall 2), (b) Concrete Drive, and (c,d) Brick Walkway.

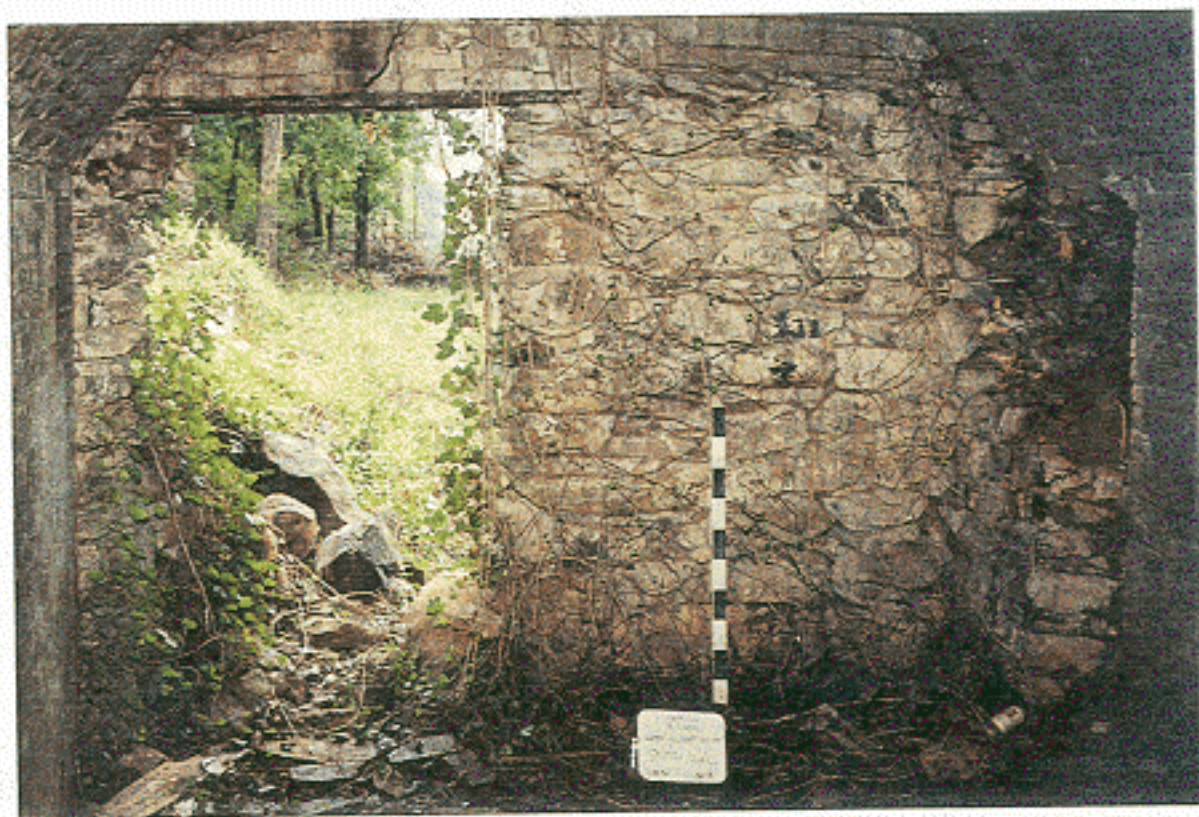
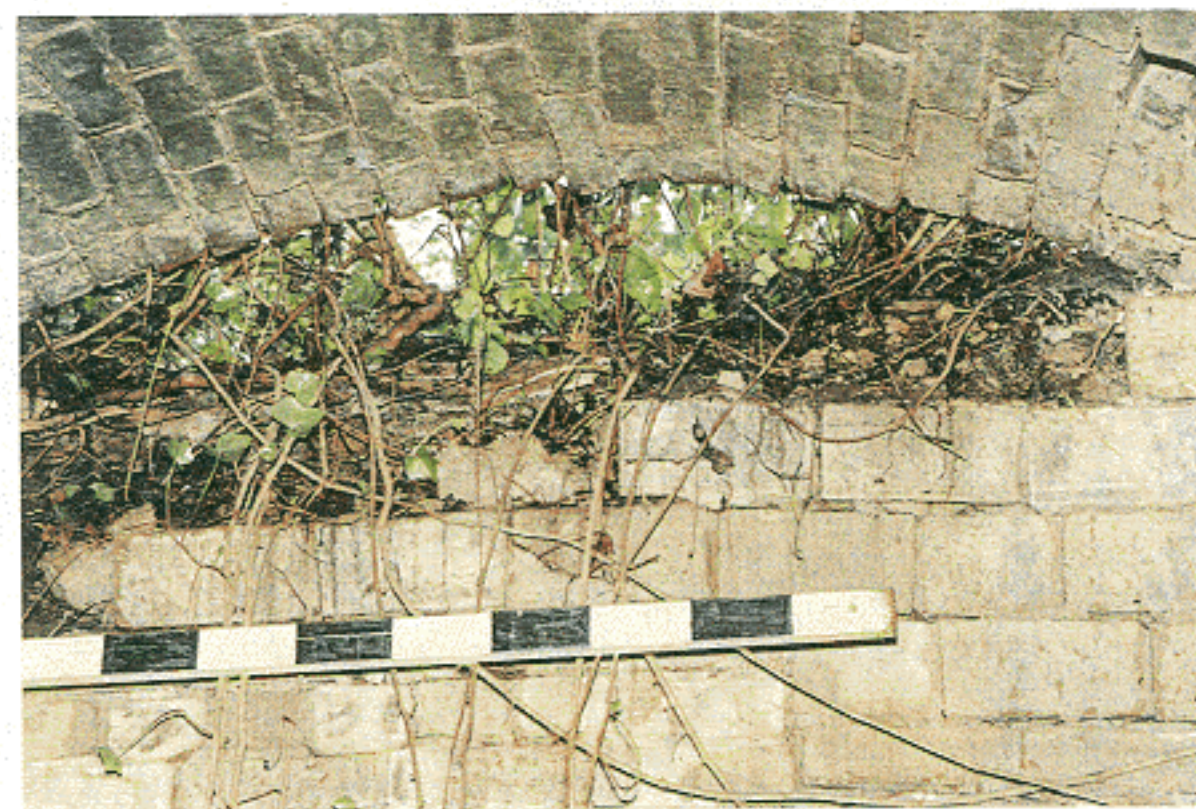
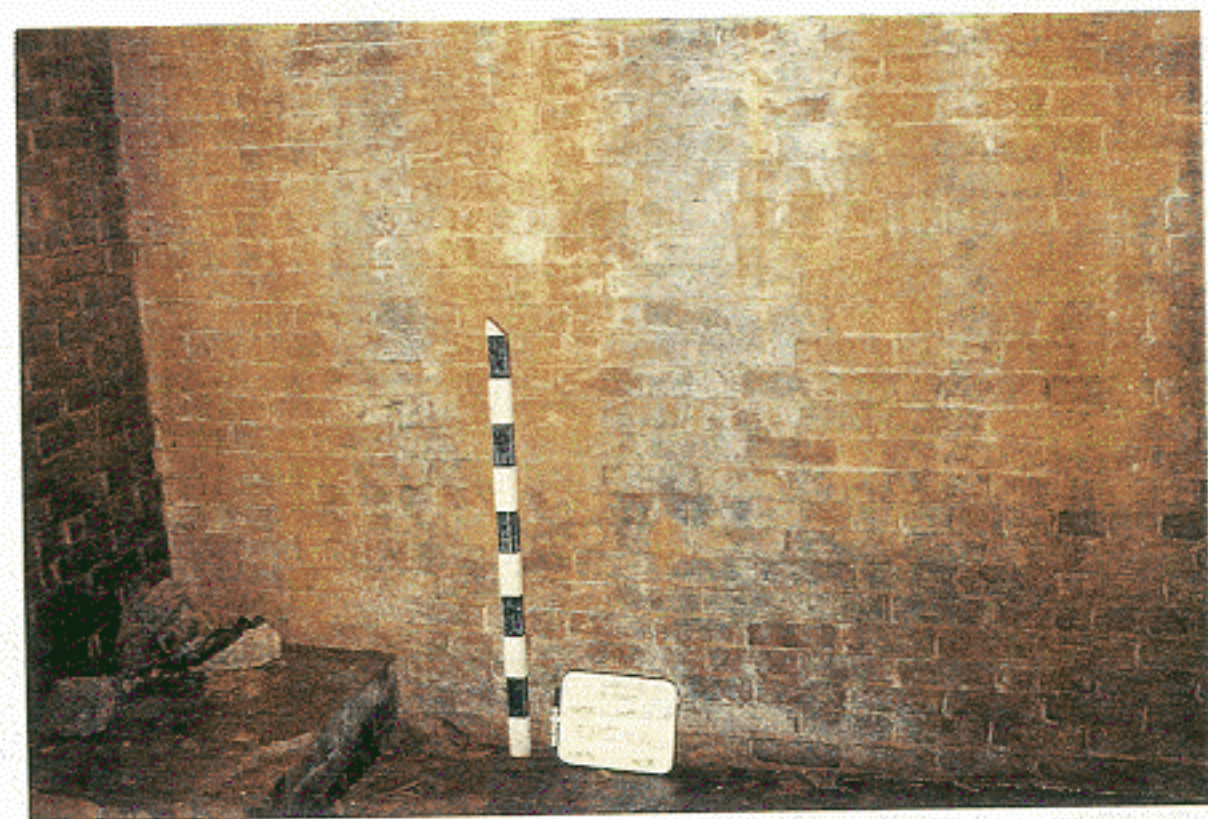
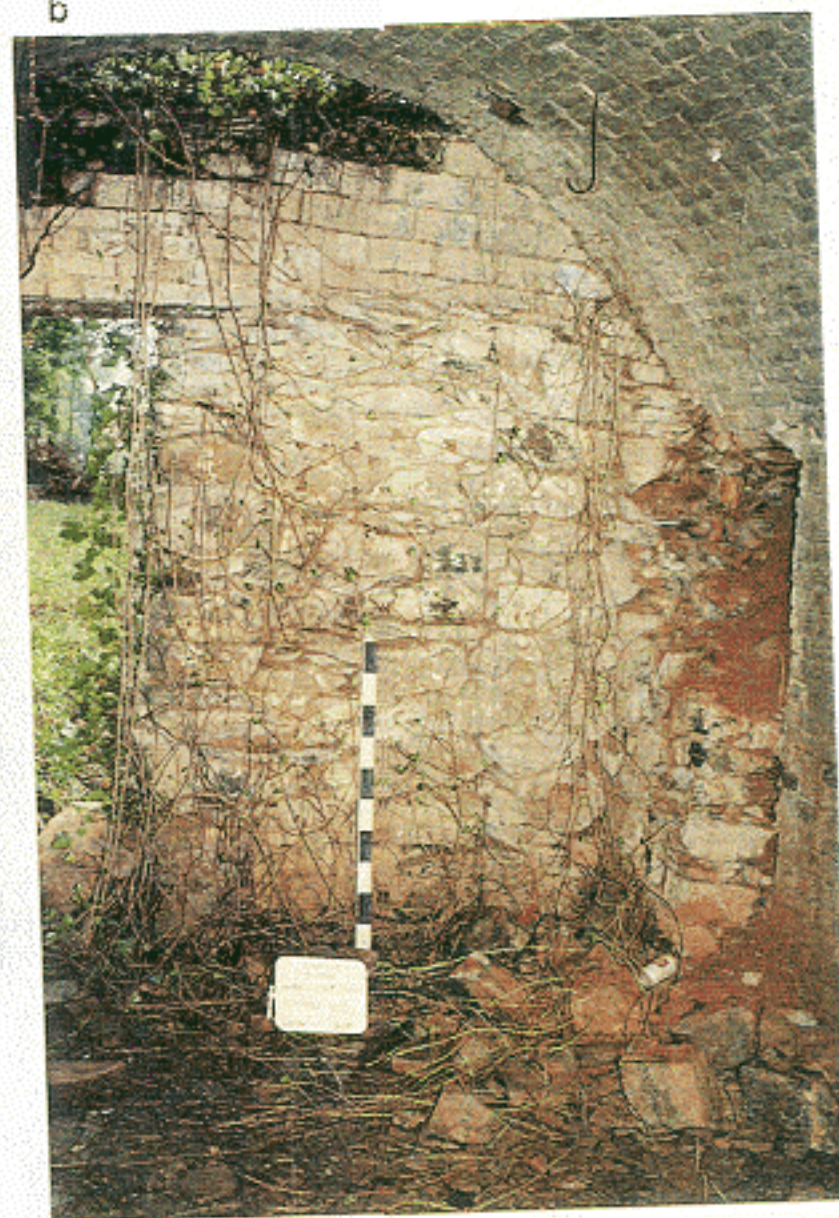
Figure 33. Interior views of the Subterranean Cellar under the First Terrace. (a) South Wall, stone (facing south); (b) Southwest Corner showing arch and iron hook hanging from ceiling; (c) North Wall, brick, with platform in corner; (d) Top of Arch on South Wall.
